Microbial Screening
Investigation Report

[Name] Medical Clinic
[Address]
[City, State]

Parks Environmental Consulting, Inc.
2233 University Avenue, Suite 325
St. Paul, Minnesota 55114

8051/8557

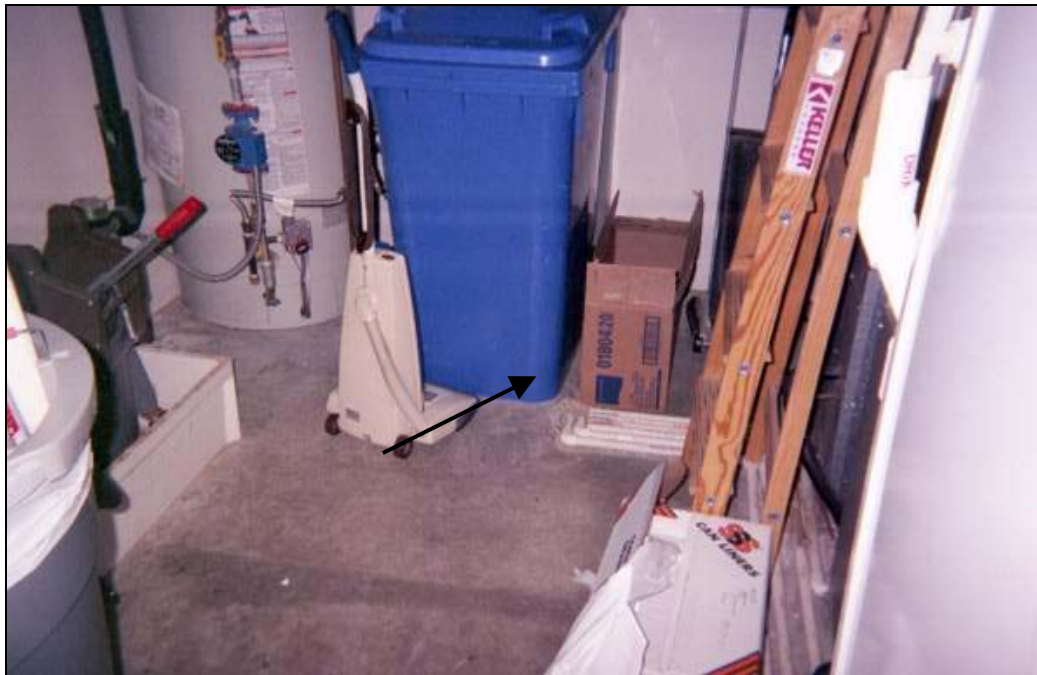
The site consists of a single story building used as a pediatric medical clinic. The building is approximately 8,000 square feet in size, built 15-20 years ago. According to the site manger, a clogged floor drain in the furnace room caused water to collect on the floor and migrate under a room wall into the adjacent room carpeting. The drain overflow and water migration to the adjacent room carpet occurred approximately 4-6 weeks prior to Parks' site visit. The total floor area wetted and affected with water was approximately 4-6 square feet in the furnace room and 10-15 in the adjacent office.

Photograph 2
Furnace Room where Drain Clogged and Water Collected on Floor

Conversations with the site manager indicate that the clogged drain has been fixed and future incidents of water on the floor in the furnace room are unlikely.

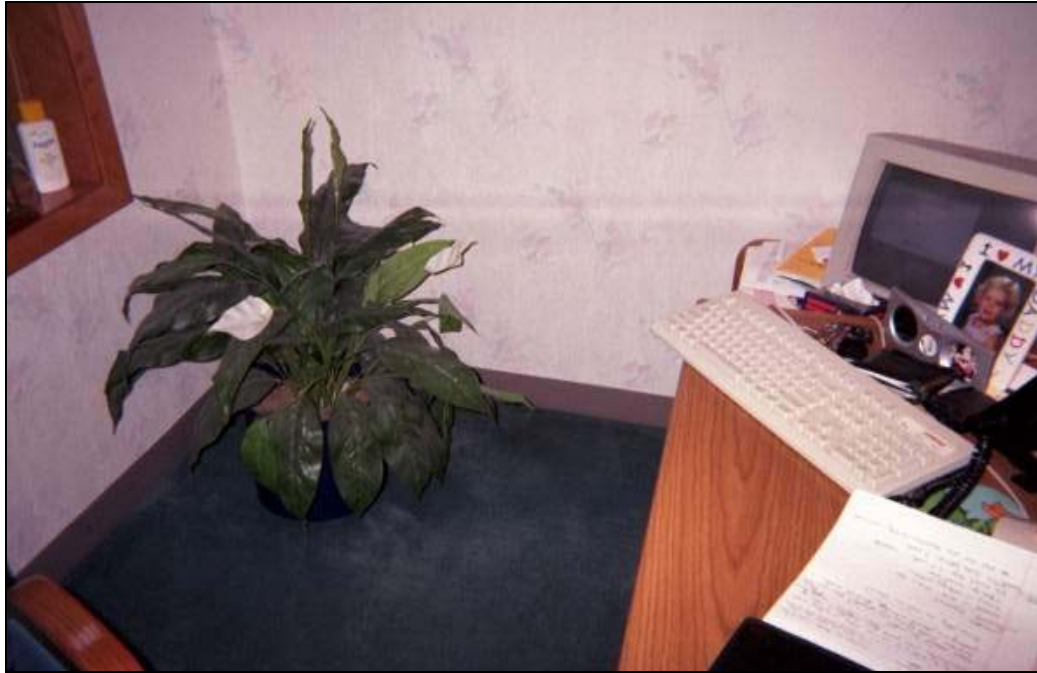
[Occupant 3's] office is where the carpet became wet due to the clogged floor drain in the adjacent furnace room. He stated there was a "musty, moldy" odor in his office at the time the carpet got wet. He is allergic to molds and has been taking medication due to increased allergy symptoms.

The results of the ambient indoor air samples indicate spore levels less than outdoor levels. The sample collected above the carpet in the wet carpet office, during brushing of the carpet, indicated higher spore levels; but not excessive. We attribute the higher spore levels seen in this sample to the agitation that was done to determine if fungal spores or parts were imbedded in the carpet.

Fungal growth can result from an underlying moisture problem. Water intrusion, chronic moisture problems and/or a relative humidity in excess of 60 percent can provide an environment suitable for fungal growth. The wet carpet episode may have contributed to mold growth within the carpet. Air sample #3 indicated higher mold spore and mold constituent (hyphal fragments) levels than the other ambient air samples. Based on this data and occupant reports of a musty odor in this office, it is likely that some types of mold propagated (but not in amounts to be visible to the naked eye) in, or under, the carpet in this room.

Photograph 3
Office Area where Carpet got Wet

It is advisable to remove the water-damaged carpet in the affected office. If done, this work should be performed using environmental containment techniques and engineering controls. We would recommend the use of employees and/or contractors experienced in fungal remediation techniques and performance guidelines.

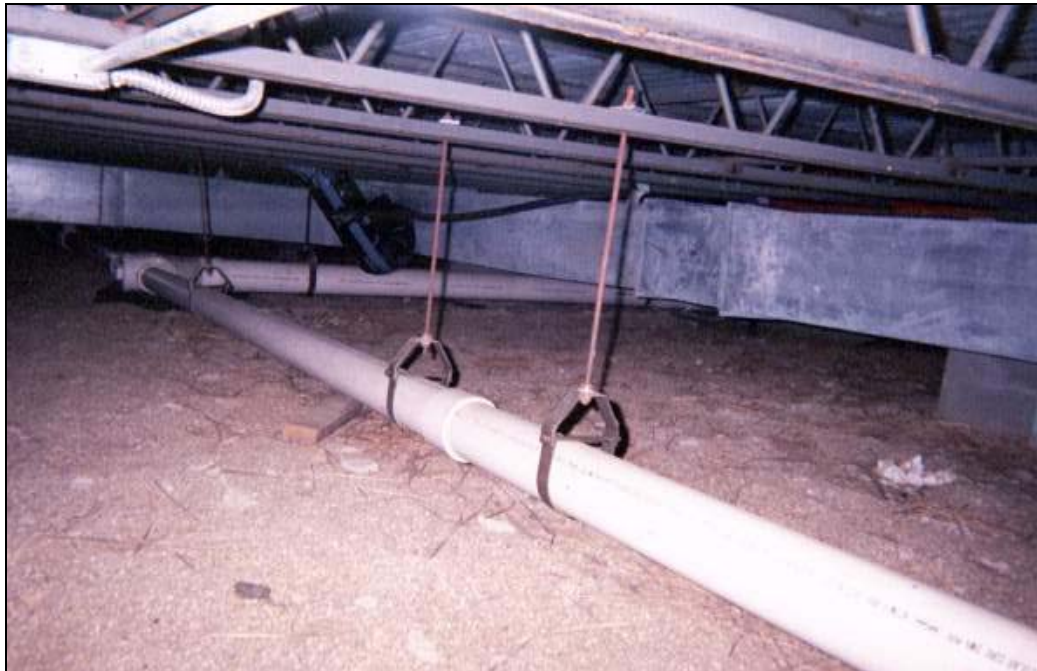
The crawlspace area was observed to be dry.

Photograph 4
Building Crawlspace
